MegaCore IP Library

Release Notes and Errata

MegaCore Library Version: 9.0
Document Version: 9.0.1
Document Date: 15 March 2009

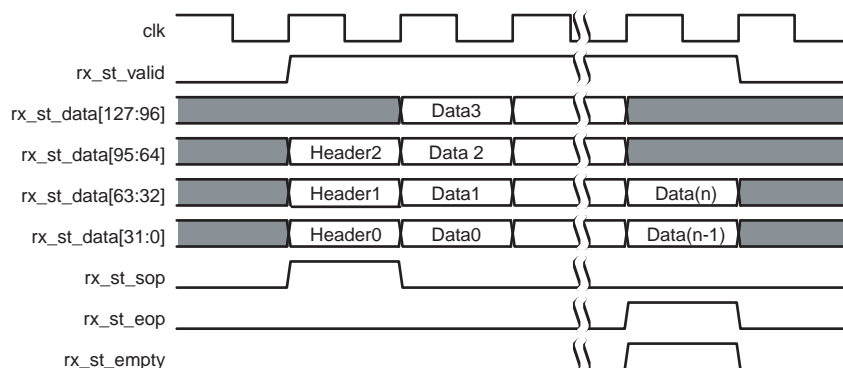
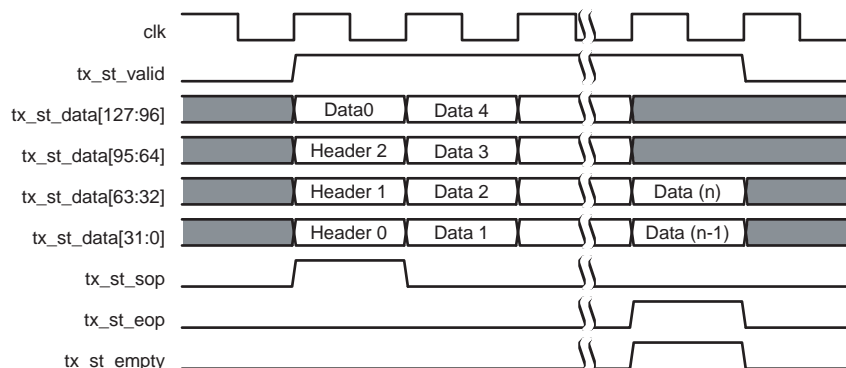
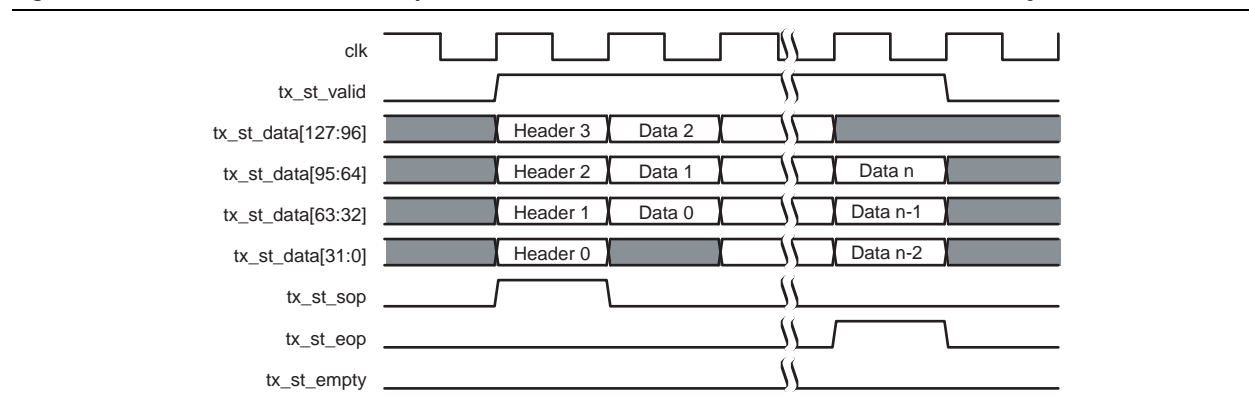
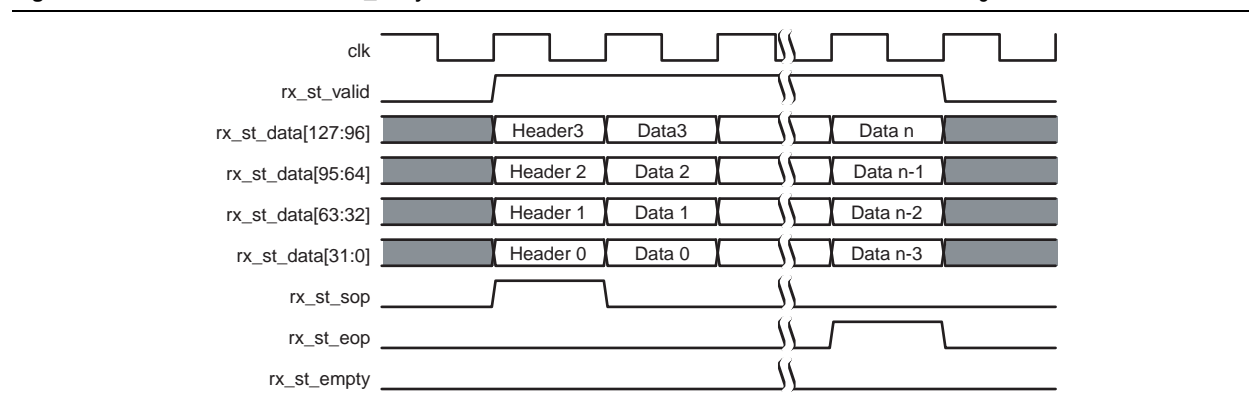
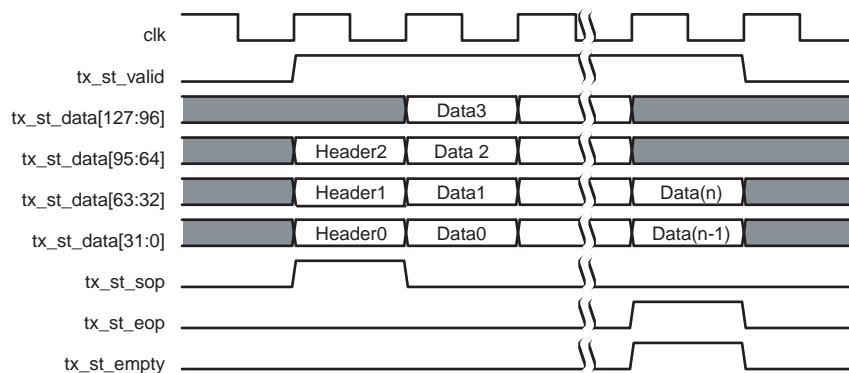
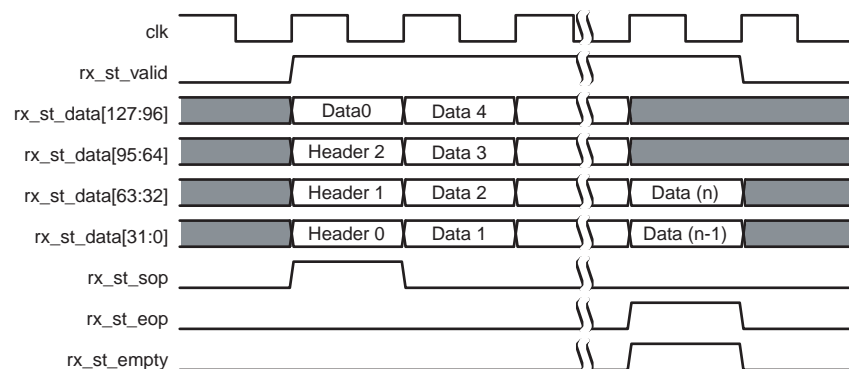
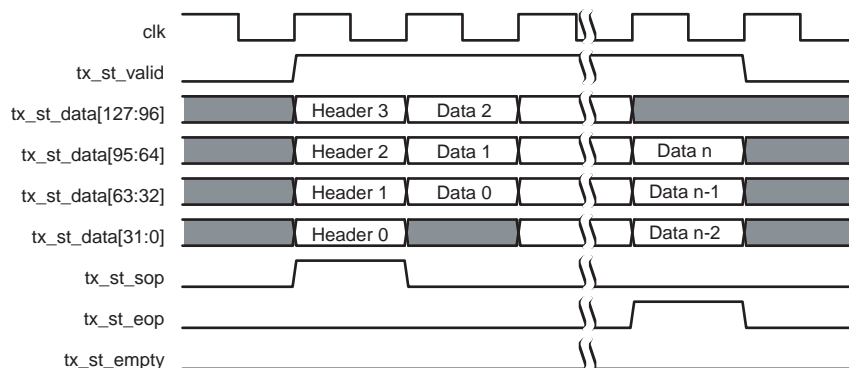
This is a documentation error only.

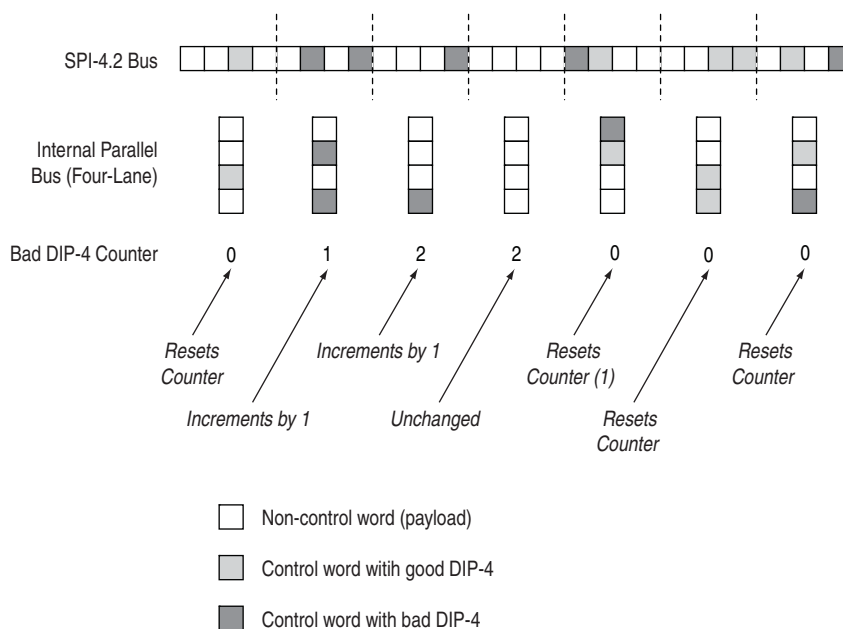
Figure 16–1. DIP-4 Counter (Note 1)

Figure 16–1 shows an example of the DIP-4 counter, where the receiver is in service state and bad threshold is 3.

(1) Receiving a good and a bad DIP-4 in the same parallel cycle resets the counter (does not increment it), so that OOS does not trigger.

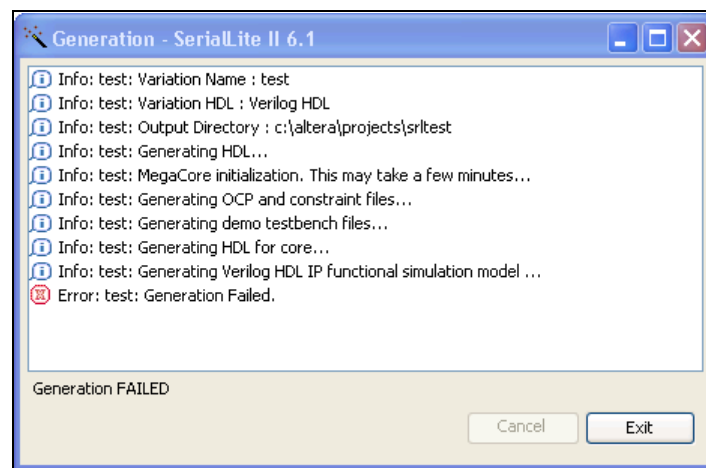
**Figure 22-1.** Syntax Error Message

If the state machine is not self-synchronized, the syntax error shown in [Figure 22-1](#) appears and the generation fails. If the state machine is self-synchronized, an invalid configuration is generated, data is corrupted, and the testbench fails.

This issue affects configurations that use the broadcast mode and for which the transmitter number of lanes does not equal the receiver number of lanes (asymmetric).
